## GREAT BOWDEN HERITAGE & ARCHAEOLOGY

# WHEN IS A CRUCK COTTAGE NOT A CRUCK COTTAGE?

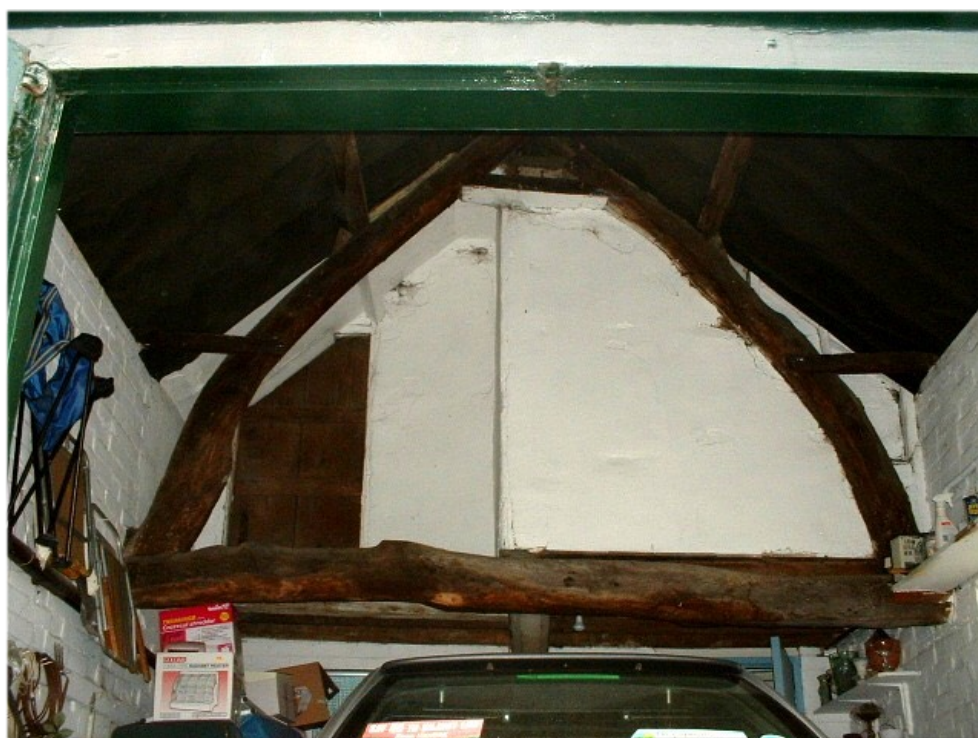
*A few years ago the Heritage Group sought help from Leicestershire County Council about identifying the remains of what we thought was a cruck cottage in a garage in Sutton Road (see photograph below)*

In a detailed reply to our enquiry we were told that this was not a cruck cottage but in fact a late style box frame cottage, found in Leicestershire in the 17<sup>th</sup> century and the first half of the 18<sup>th</sup> century.

The expert consulted thought it would have been the roof of a hovel or possibly a small outbuilding and the wood in the tie beam would have originated in the hedgerow rather than from woodland. Apparently there are other similar examples in Great Bowden in association with mud constructed dwellings. This particular example may have been moved to its present position from elsewhere.

Here is an example of a box frame construction similar to the photo which we submitted.

Apparently there are other similar examples in Great Bowden in association with mud constructed dwellings. This particular example may have been moved to its present position from elsewhere.

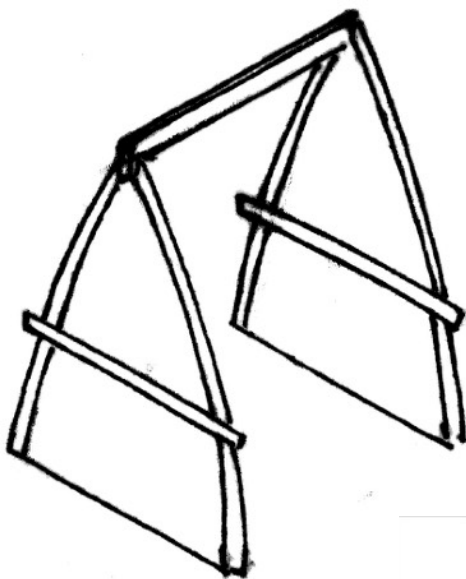
A true cruck cottage was basically a roof with the main beams carrying the weight of the roof directly to the ground. The walls were then filled in with material that was not load-bearing.

Here are diagrams of a cruck cottage:

*Load bearing frame*

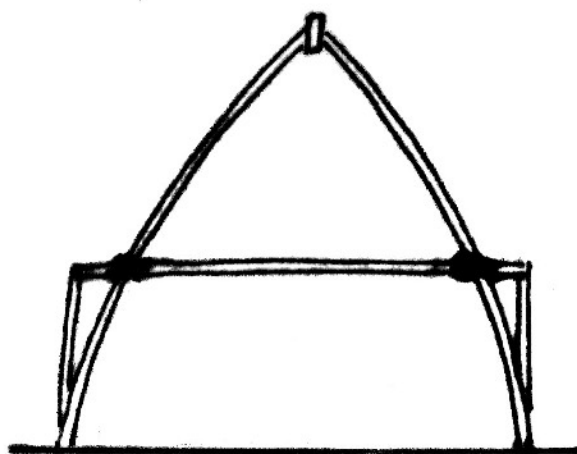
*Walls built on a separate frame*

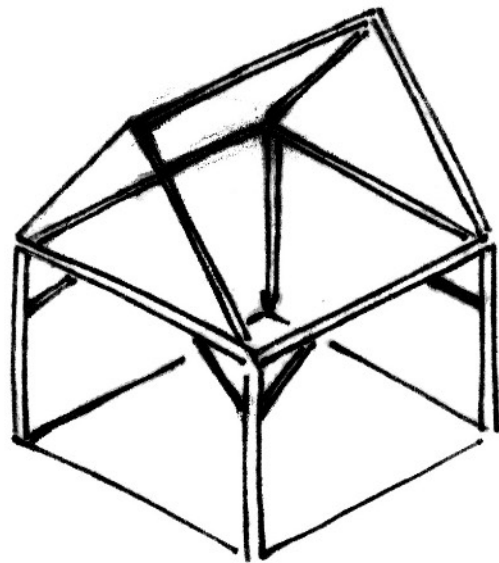
In the case of the box frame there was a distinct roof with the trusses transferring the weight of the roof onto the wooden box frame beneath.

*Roof sits on walls of  
box frame*
